PC-A5530

Spectro Samples  
Location Diagram

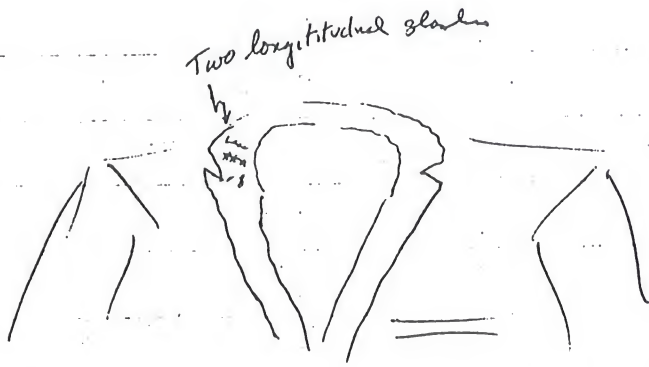
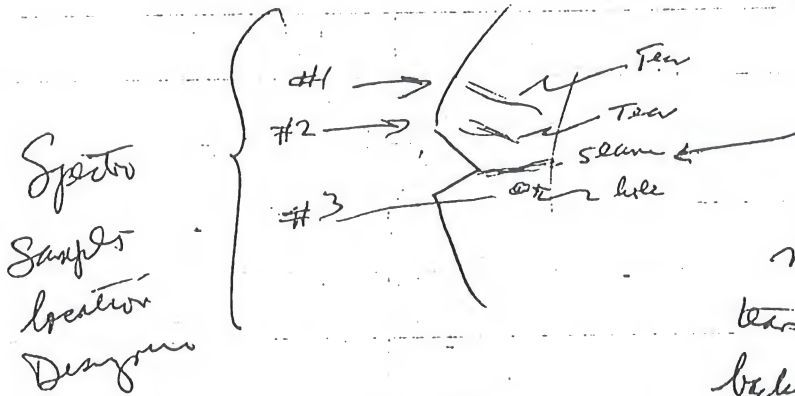
Black suit coat had  
two longit. tears on  
collar (right side) just  
above the V cut on collar  
one round shaped hole  
or tear just below  
seam

none of these holes or  
tears went through the  
backing material or the  
collar of the coat.

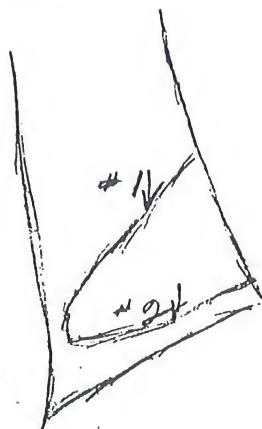
WHITE SHIRT - Q 76

SHIRT COLLAR →

# 3 is control from back of skirt in bloody area.

hole torn in collar  
of shirt
